1. Report No.	2. Government Accession No.	3. Recipient's Catalog No.							
NASA CR-121158		N73-22891							
4. Title and Subtitle		5. Report Date							
AIRCRAFT ENGINE SUMP	FIRE MITIGATION	31 January 1973

SUMMARY

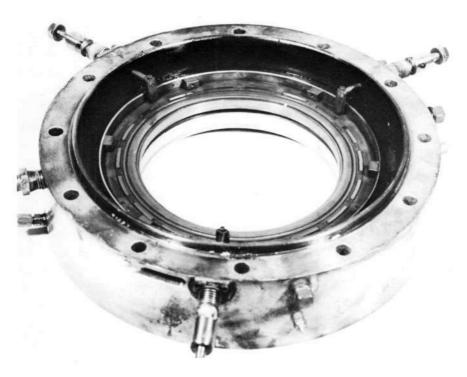
ENCLOSURE 6

Seal and Seal Housing Showing Lift-Off Mechanism

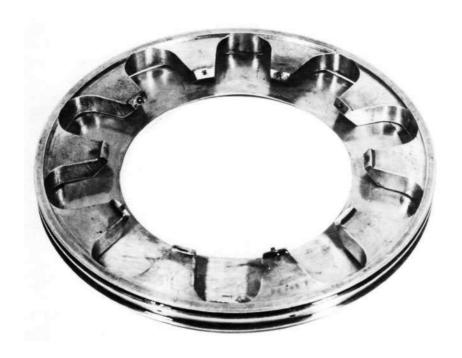
Lubrication Jet Ring and Baffle Plate

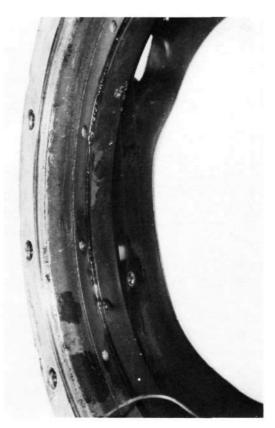
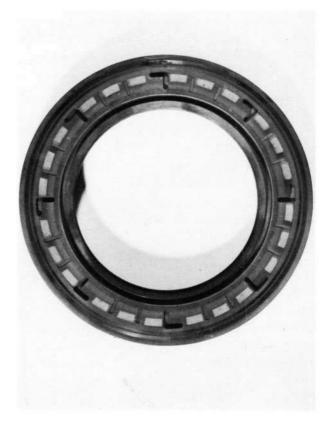
ENCLOSURE 11 SEAL COMPONENTS AND BAFFLE PLATE AS REMOVED FROM RIG AFTER ESSO 4040 TESTING

Carbon Nose Piece And Housing

Baffle Plate In Rig Housing 36 Sector

Carbon Nose Piece

In general the components were in good condition, except the seal, but required cleaning. Photographs of the seal housing and baffle plate, and the seal as removed from the test rig are shown in Enclosure 11.
